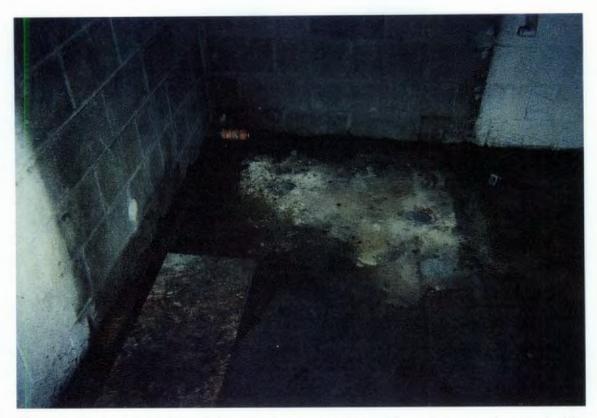
Photo 5: Boring 4BE(10') 4.5-5' at southeastern corner of the pressure wash room inside the manufacturing/office building.

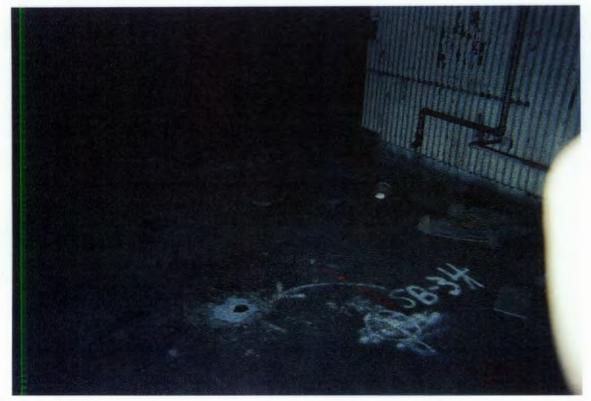
Photo 6: Boring SB-34 located inside the manufacturing/office building.

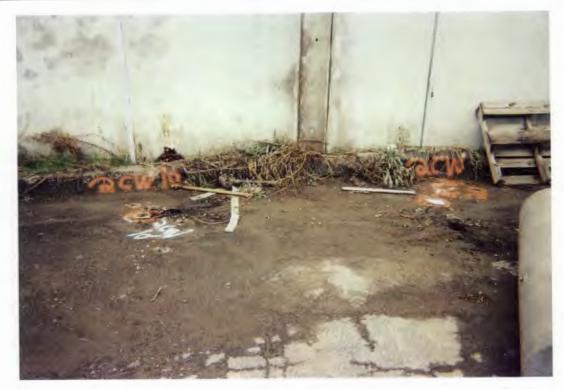
Photo 3: Soil borings 2CW(10') and 2CW(20') located west of stormwater collection sump and pump along southern border of the Site.

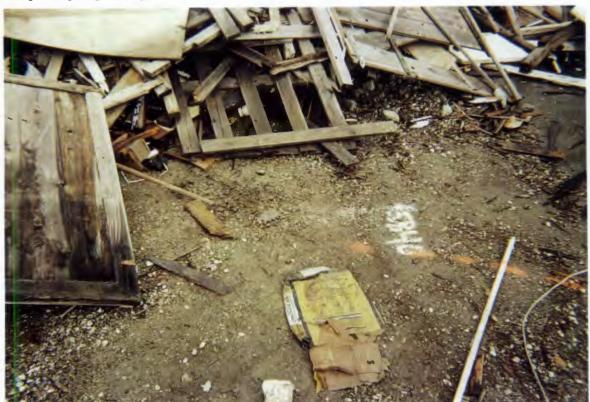
Photo 4: Soil boring SB-40 located in unpaved area immediately west of paved parking area.

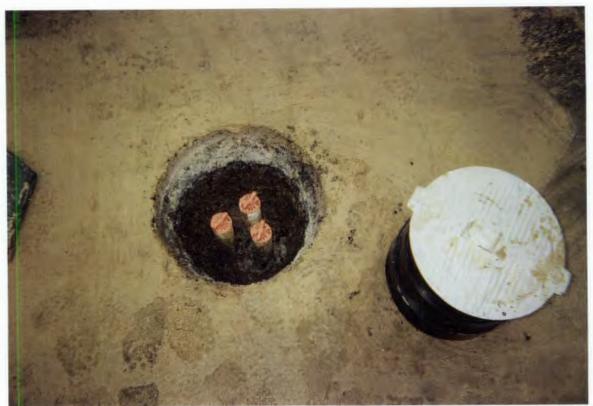
Photo 7: Nested well (NW-1) located along northern border of Site before installation of traffic box.

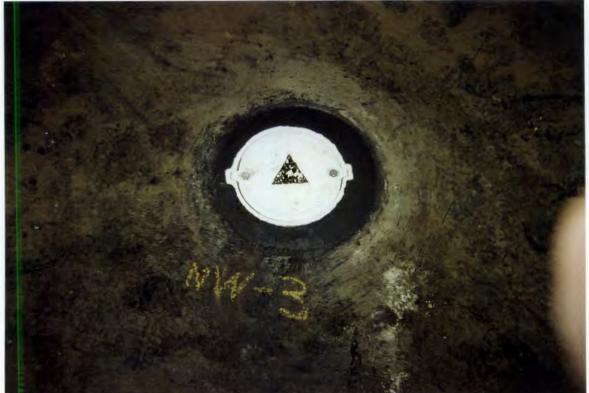
Photo 8: Nested well (NW-3) located along southern border of the Site after installation of traffic box.

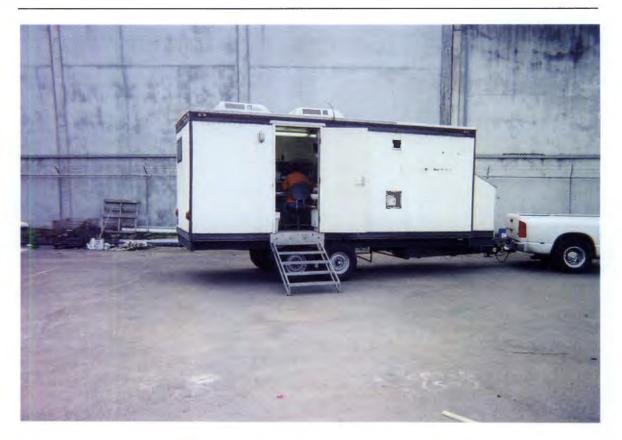
Photo 9: TEG's mobile laboratory shown on the Site in December 2005.

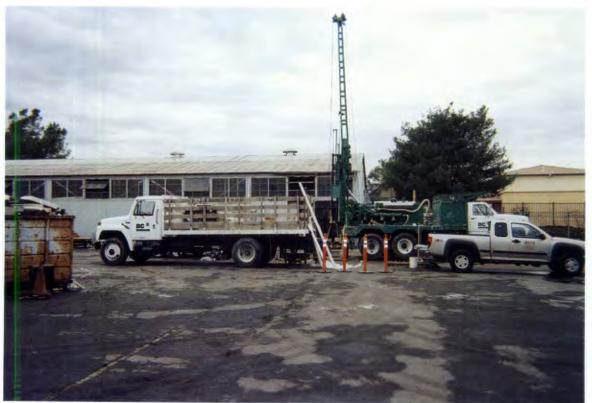
Photo 10: BC² Environmental drill rig and support truck during installation of nested well NW-2.

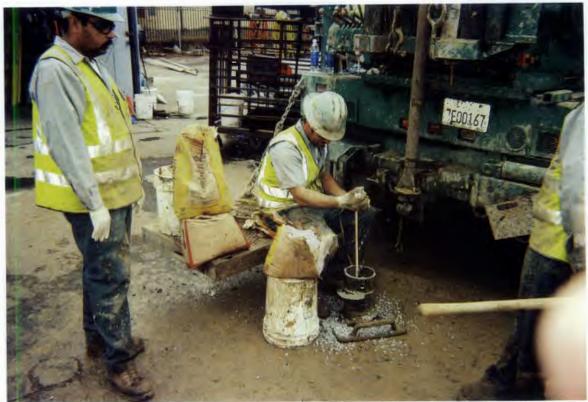
Photo 11: BC² Environmental crew during installation of nested well NW-2.

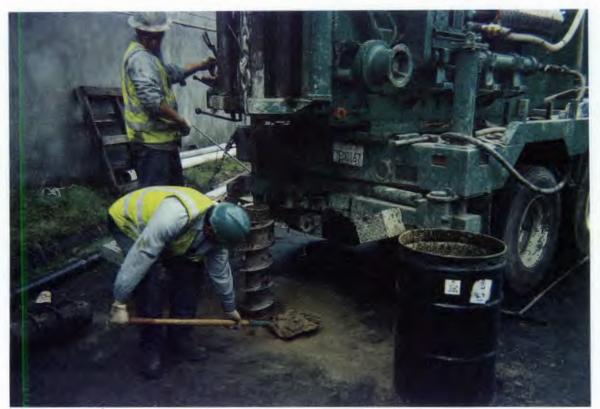
Photo 12: BC² Environmental crew during installation of nested well NW-3.

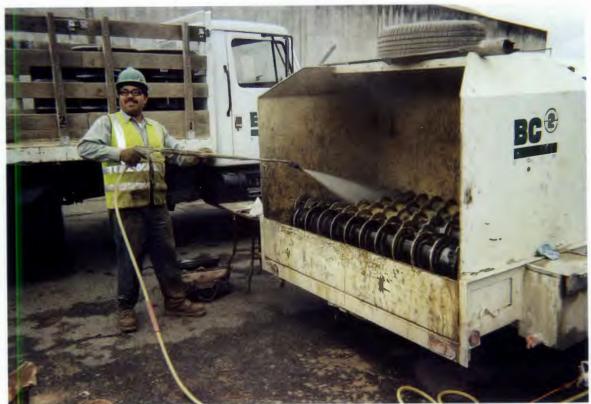
Photo 13: BC² Environmental crew steam cleaning augers used for drilling nested wells.

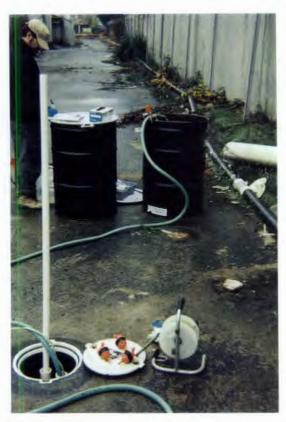
Photo 14: Sampling equipment used during collection of groundwater samples from nested wells.
